Rear Building at 69 Lisbon Rd., Sabattus, ME

# Dangerous Building

Exhibit C

RE: 69 Lisbon Road, Sabattus, ME, HCW Project No. 18-070

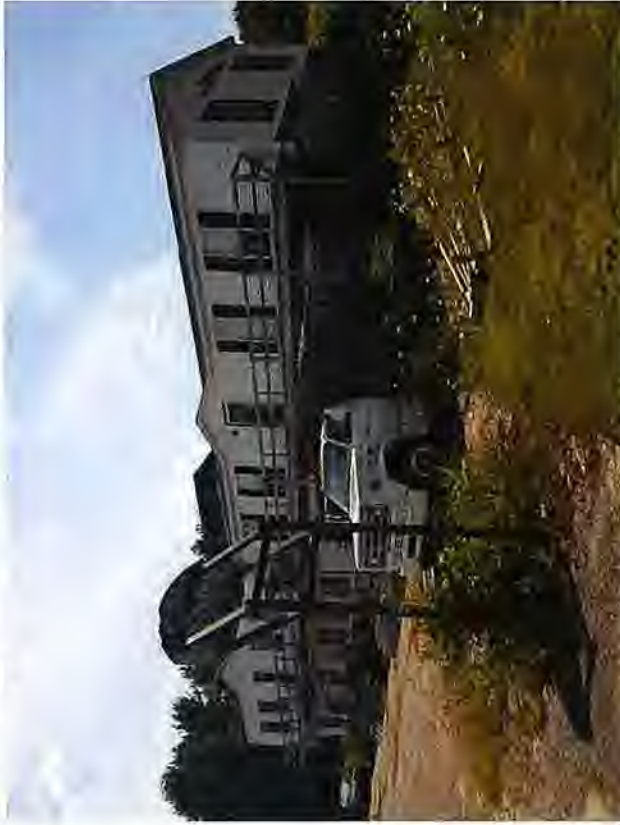
The structure located to the rear of the main structure is a safety hazard and is considered a Dangerous Building.

This picture represents the exterior of the building showing the current state of the structure. Failing roof shingles, dilapidated decks without proper supports and railings, exterior walls openings exposed to the elements, improper egress entries...

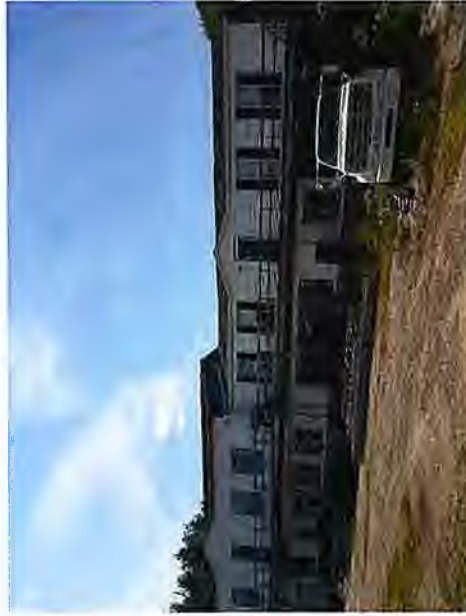
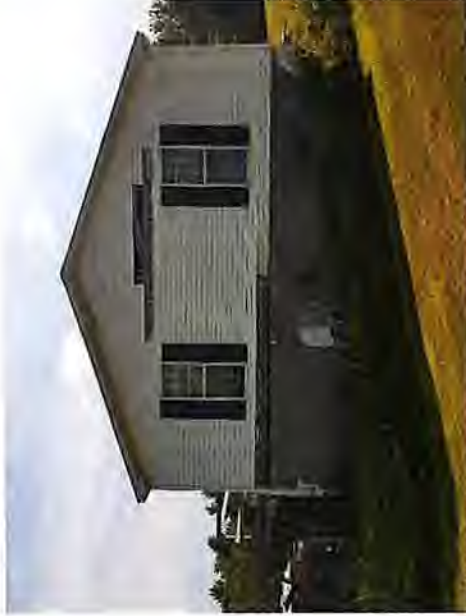
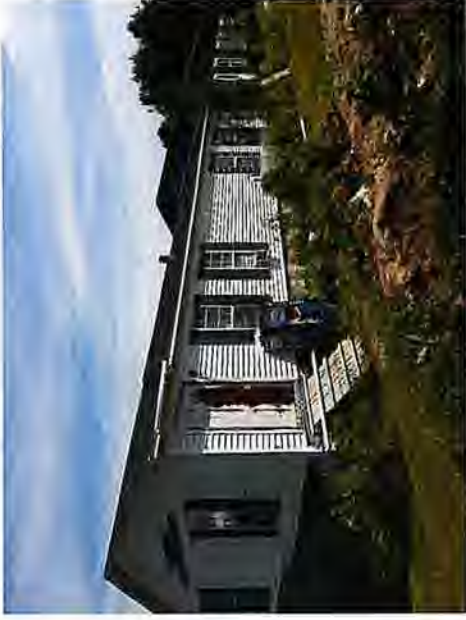
Evidence of complete structural failure of the foundation supporting the building.  
Also shows evidence of the space being used as a dwelling.

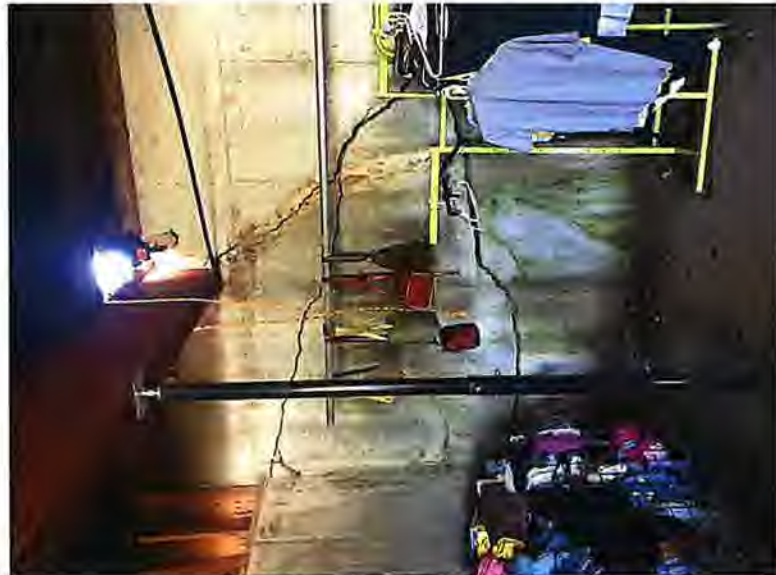
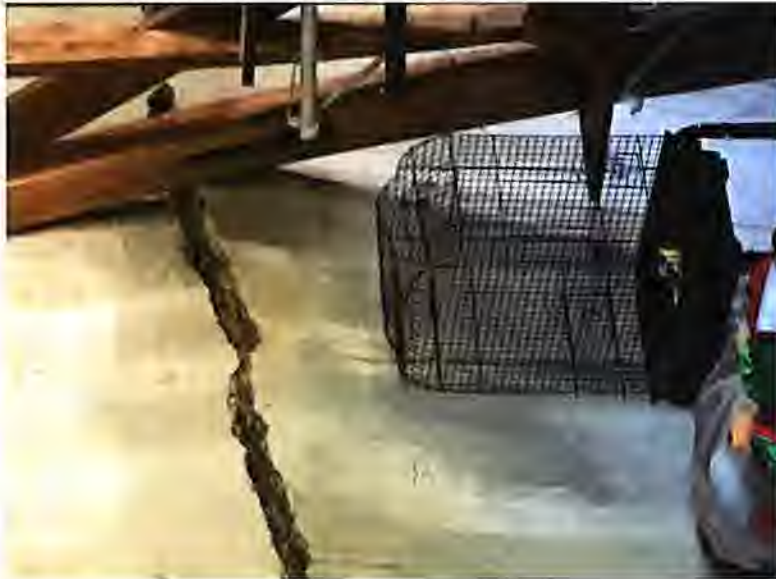
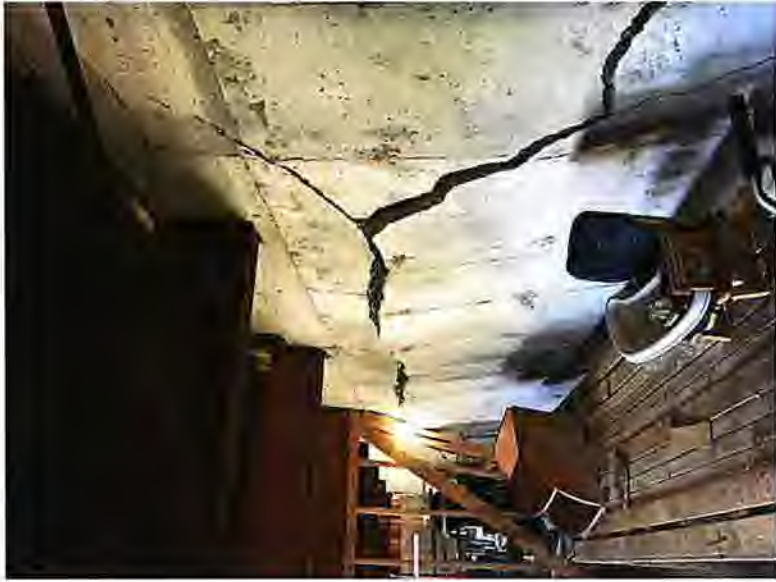
Evidence of water lines hooked up to the building to supply water to a dwelling unit.

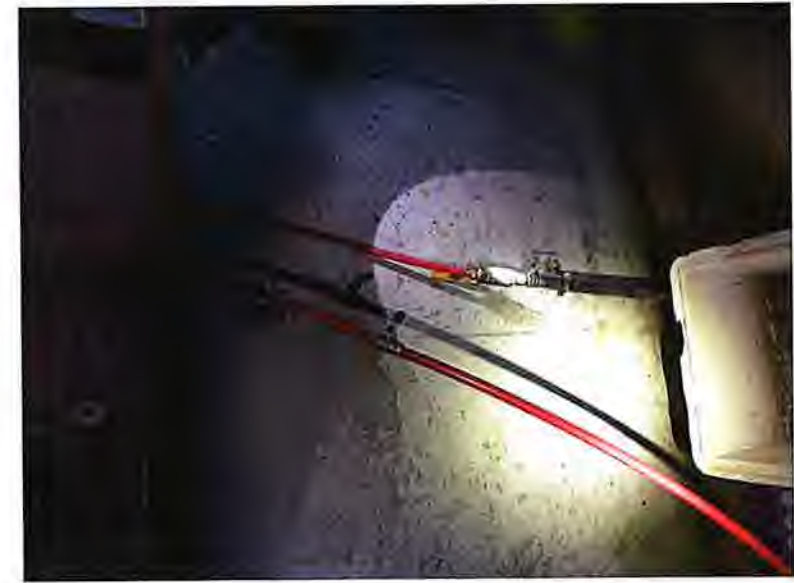
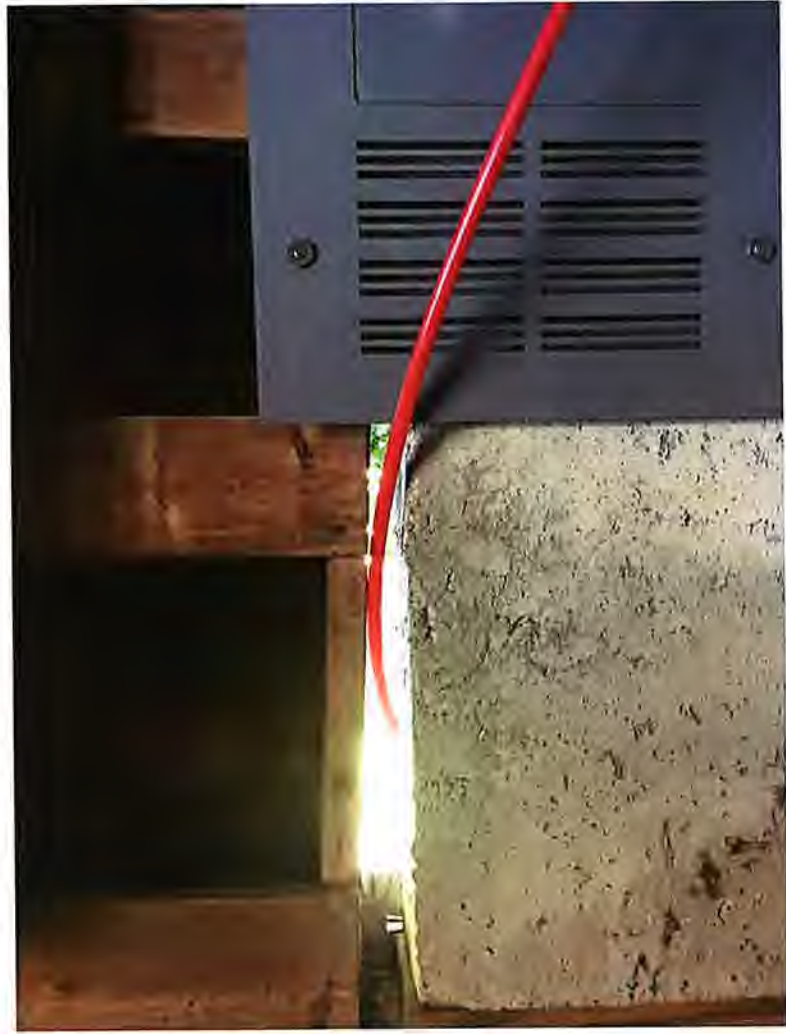
Electrical Safety Hazard – Exposed service panel

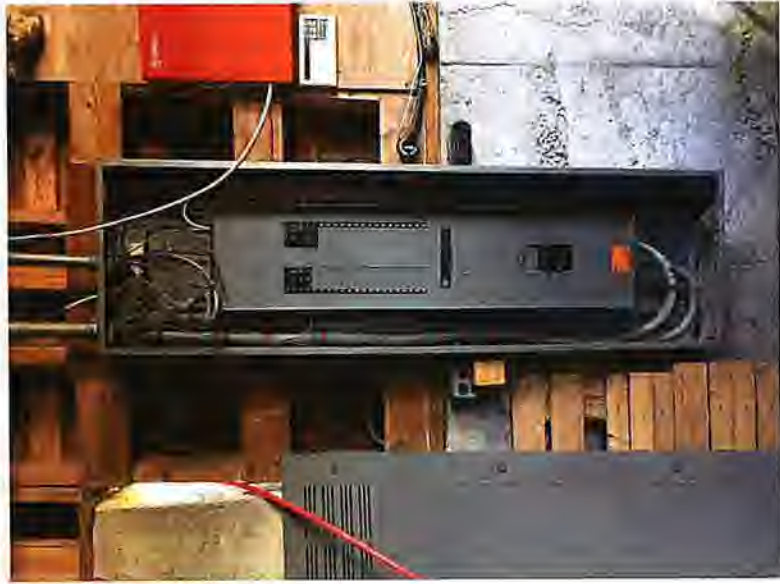
Gas line? entering building – Safety hazard

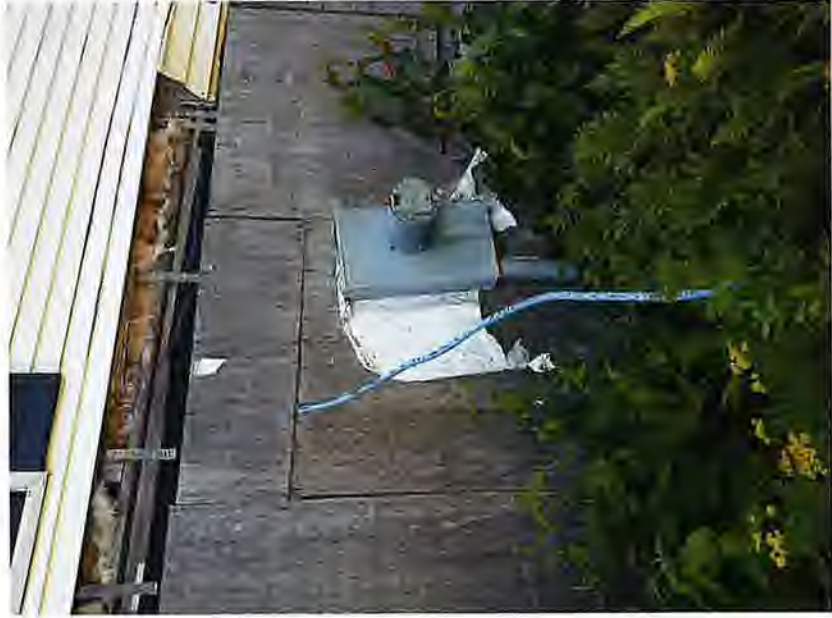
Opening in floor from main building level to basement – No stairs – Safety hazard

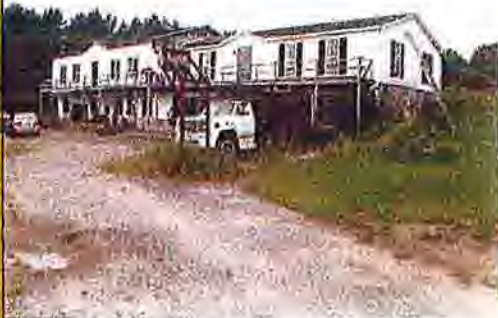
Front and Right Exterior

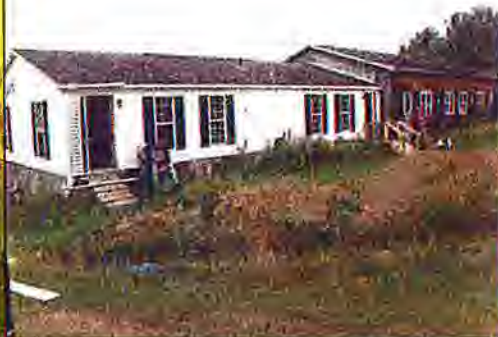
Back and Right Exterior

Next, I recommend that the grade at the back of the house be changed to divert the water coming off the hill to the left and right of the building with a swale. With the temporary support and the swale, the building should be able to go through this coming winter without significant additional damage.

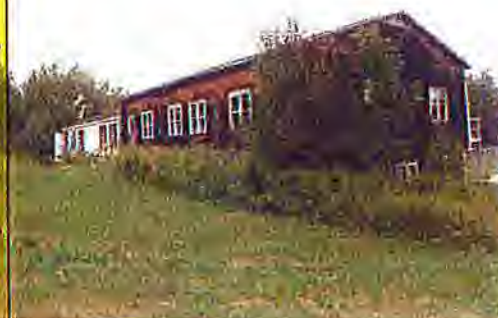
Back and Left Exterior

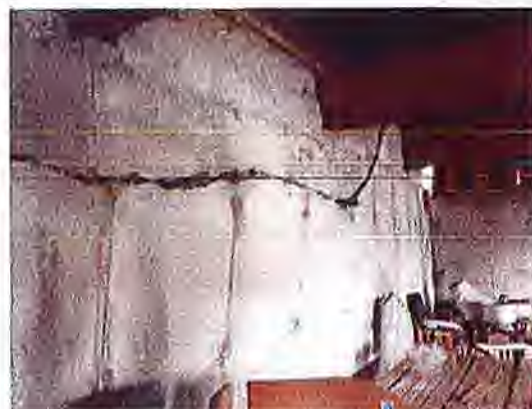
The back foundation wall has a large horizontal crack running most of the length of the wall. This appears to be due to freeze-thaw conditions with the building being unheated, and the ground sloping up behind the building provides water behind the retaining wall in addition to stormwater coming off the back of the roof.

The modular portion of the building is supported with steel beams running front to back. The steel beams have temporary jacking columns except at one beam. The columns are around 57" inside the concrete wall. The unsupported beam should be resupported.

Horizontal Crack, Right end of Back Foundation Wall. Note Steel beams to be Supported

The truss-framed portion of the building should also be supported to take the building loads off the failing concrete wall. One method is to install a beam at 50" inside the concrete wall; this is a panel point for the wood trusses. The beam can be supported by three jacking columns and would need to be a W10x12 if there are four supports (3 spans).

The back concrete wall should be removed and replaced. This will require excavation down to the footings. The footings should be reusable, though if they have cracked please call me for an inspection before continuing. I am assuming that the soils are silty sand or gravel with a loading capability of 2000 psf – no clay, peat, or ledge. The new concrete wall should be a 10" deep wall with 3000 psi concrete. The new wall will be pinned to the existing footing and the left and right foundation walls with a 18" #4 dowel drilled and epoxied 6" into the footing at 4' on center. The vertical reinforcing steel shall be a #6 bar at 2' on center. The horizontal reinforcing steel shall be #4s at 2' on center. No horizontal reinforcing is needed above grade.

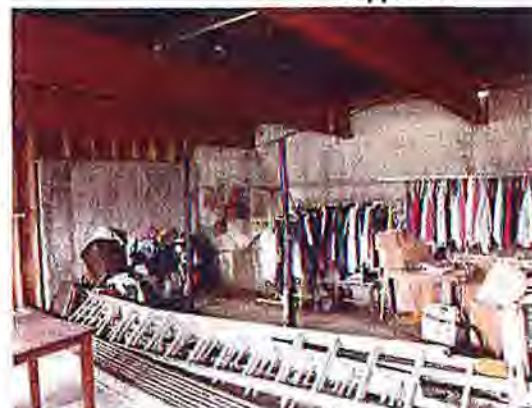
Temporary Supports for Steel Beams, Existing Buttress

The jacking columns should be placed on wood blocking or a precast round concrete footing to spread the loads out on the concrete slab. The beams should be fastened in place top and bottom so they can't kick out in a high wind, for example.

The existing wall has a buttress wall between the modular and truss sections. This should be retained, and the new wall should be doweled into the buttress. Because of the length of the back wall, I recommend adding a 4' wide x 6' deep x 8" thick buttress doweled into the floor and the new wall at the other two interior walls in the basement.

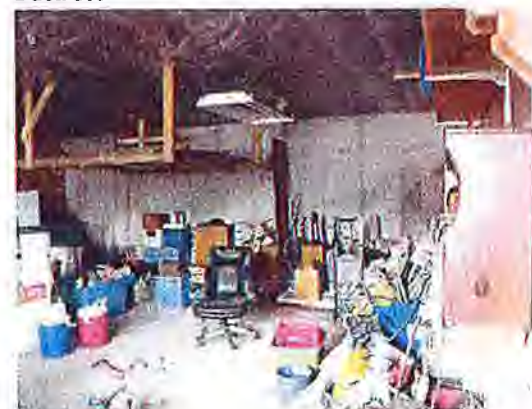
Wood Joists in Right Side of Truss-Framed Portion, Horizontal Crack
